## **DEPARTMENT OF TRANSPORTATION**

**[Docket No. FAA-2016-4228; Directorate Identifier 2015-NM-107-AD]**

**Airworthiness Directives; Airbus Airplanes**

**ACTION:** Notice of proposed rulemaking (NPRM).

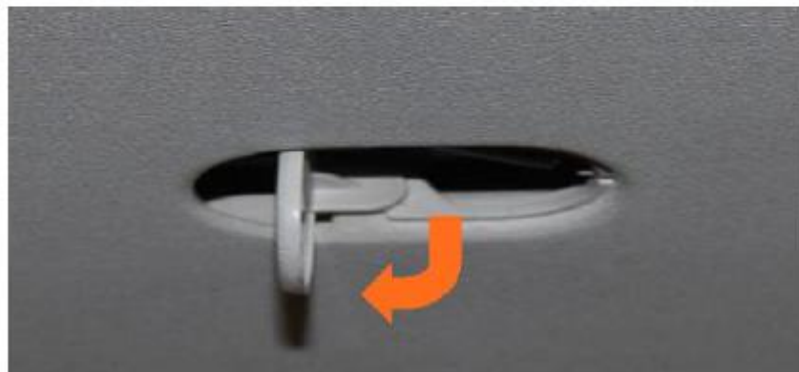
**Picture B:**

**Design A:** The placard on the passenger oxygen container test button is as described in Picture A of Appendix 1 of this AD. The Mask configuration ("ZZ" in Picture A) is a number and the test button is as shown in Picture B.

Note 2 to figure 1 to paragraph (i)(7) of this AD: For “Design A,” the placard on the passenger oxygen container test button is as described in “Picture A” in figure 1 to paragraph (i)(7) of this AD. The mask configuration (“ZZ” in “Picture A”) is a number, and the test button is as shown in “Picture B.”
